Fire Station No. 11

Historic Structure Report

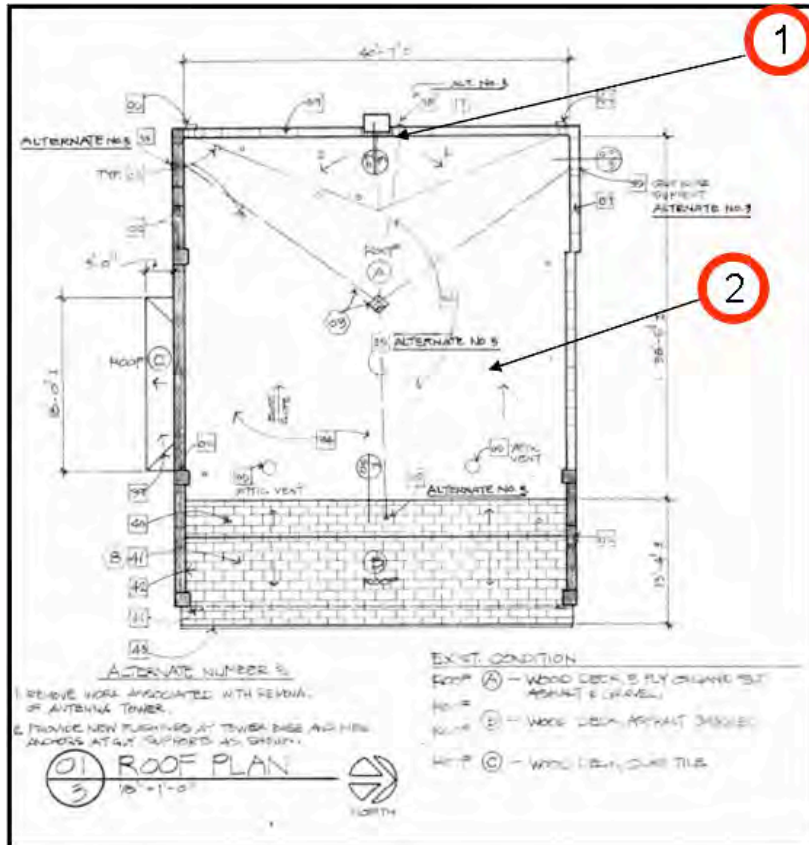
1989 Roof Plan

- (1) Removal of antenna tower, guys, supports, concrete base, etc.
- (2) Removal of existing composition roofing and deteriorated roofing components, replacement with new material

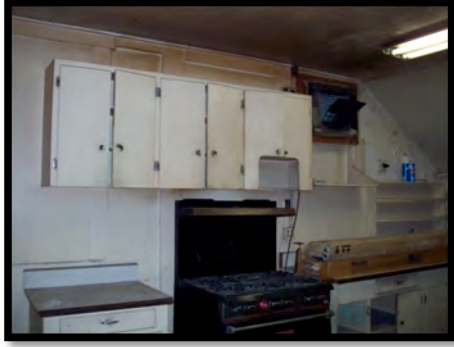
Figure 57: If cabinets are to be used by the public they shall be lowered to recommended height. Lower cabinets would require knee space for acceptable forward reach.

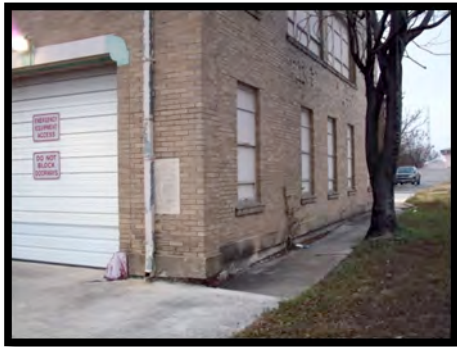
Figure 58: Sidewalk must be reconstructed to allow free access without any changes in levels due to land shifts.

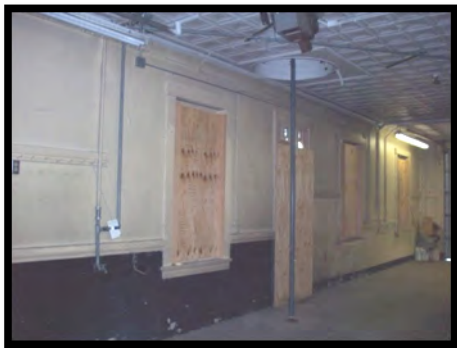
Figure 62: All doors on first level shall be verified at 3'-0" for accessibility. If door does not have clear width of 3'-0" then it shall be replaced or made non-public.

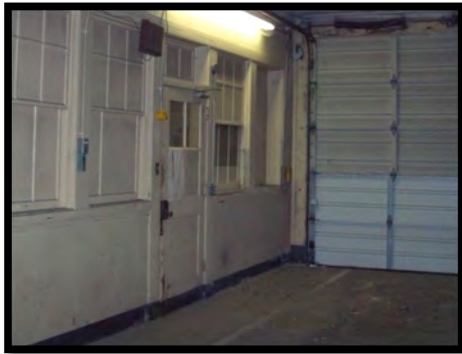
Figure 63: Doors on first level shall have new hardware that does not require twisting of the wrist if it is to be used as a major passageway. It is recommended that a panic device be used for easy exit.

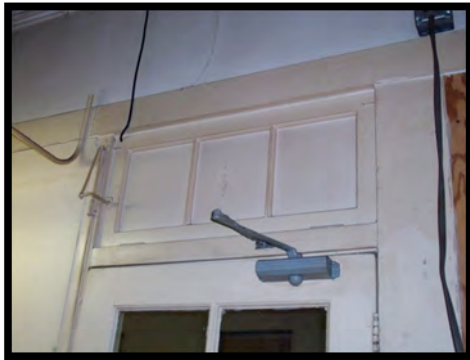
Figure 64: Doors on first level shall have working door closers

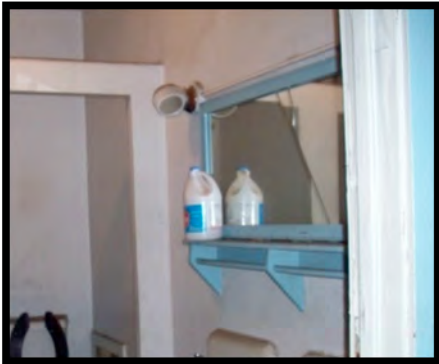
Figure 65: If mirrors are to remain they shall be no higher than 40" above finished floor (AFF), they shall be replaced or relocated as needed.

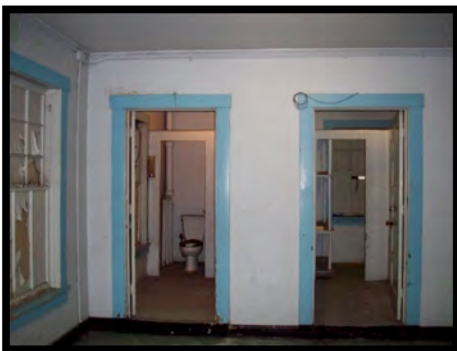
Figure 66: If toilet rooms on second level are to be used, the doorways need to be 3'-0" wide, if not the doors shall be replaced or new accessible toilet room shall be constructed on first level.

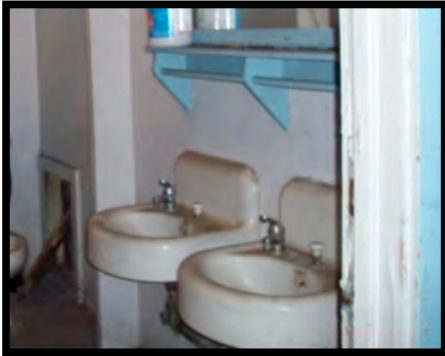
Figure 68: If sinks are to remain and made operable, they shall have a height of 34" AFF to rim. If sink is to be operable with hot water, then exposed pipes shall be covered with insulation and faucets shall be replaced with push-type.

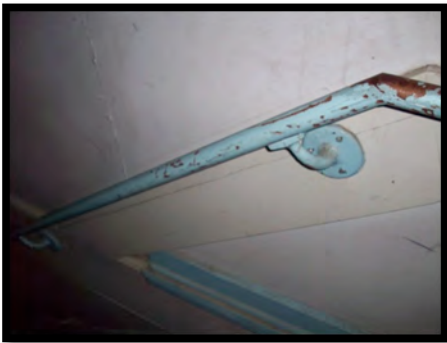
Figure 69: Handrails at stairs shall be verified with 4.26.2 and shall have proper gripping surface. If current handrails do not meet requirements they shall be replaced with new.

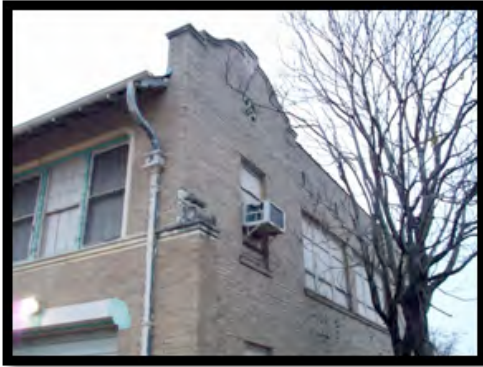
Figure 76: Identify mechanical equipment such as A/C units that are not working efficiently and replace them with more efficient units.

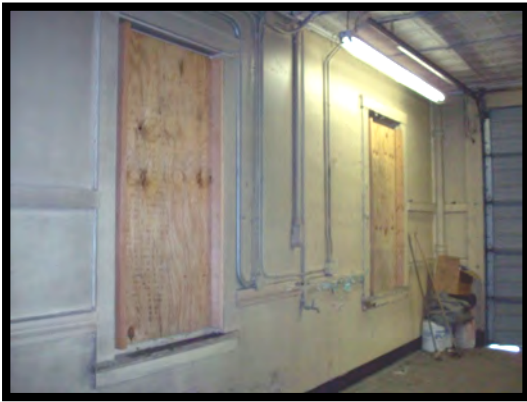
Figure 85: Provide high performance glazing or remove paint and plywood from existing windows to maximize interior day lighting.

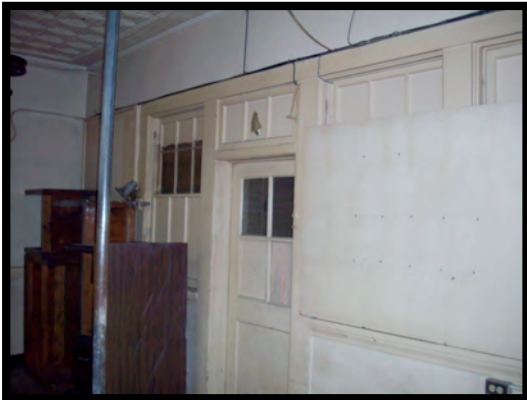
Figure 86: Remove paint on windows to allow a line of sight to the outdoor environment
